Report No. UT-10.20

ASSESSING CORROSION OF MSE WALL REINFORCEMENT

Utah Department of Transportation
Research Division

September 2010

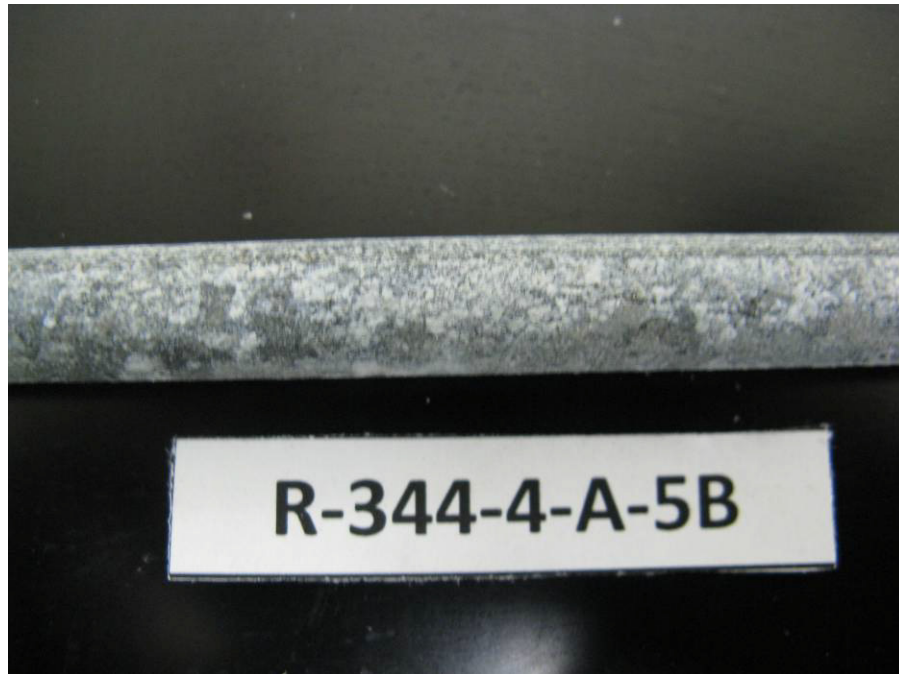
Figure 7 Typical condition of extracted wire coupons

During the month of June 2010, twenty-two wire coupons were extracted from select MSE walls. Fifteen coupons were from one-stage walls and seven were from two-stage walls. A detailed list of these coupons was presented previously as part of Table 3 in Section 2.5. Our field observations confirmed that all of the coupons consisted of size W11 (MW 71) steel wire with a 16-UNC threaded end. All of the wire coupons were galvanized steel, but the conditions in the access hole often varied from those shown previously in Figure 3. In no case was the void in the hole filled with “corrosion inhibiting mastic.” In most cases, the void was unfilled and the threaded end of the wire was either left exposed behind the neoprene plug or covered by a plastic cap. In a couple of instances the void was filled with an expansive aerosol foam which appeared to trap water within the hole. The actual lengths of the nominally 78.7-inch (2.000-m) long wire coupons were found to range from approximately 77.9 to 123.8 inches. Generally, the galvanization appeared to be intact but exhibited a variable amount of white oxidation product, sometimes referred to as “white rust.” A photograph showing the typical condition of the coupons is shown in Figure 7.

In some places the galvanization appeared to have flaked or spalled from the underlying steel. A minor amount of localized steel corrosion (i.e., “red rust”) was observed on several of such specimens. Photographs illustrating these conditions are presented later in Section 4.2.3.

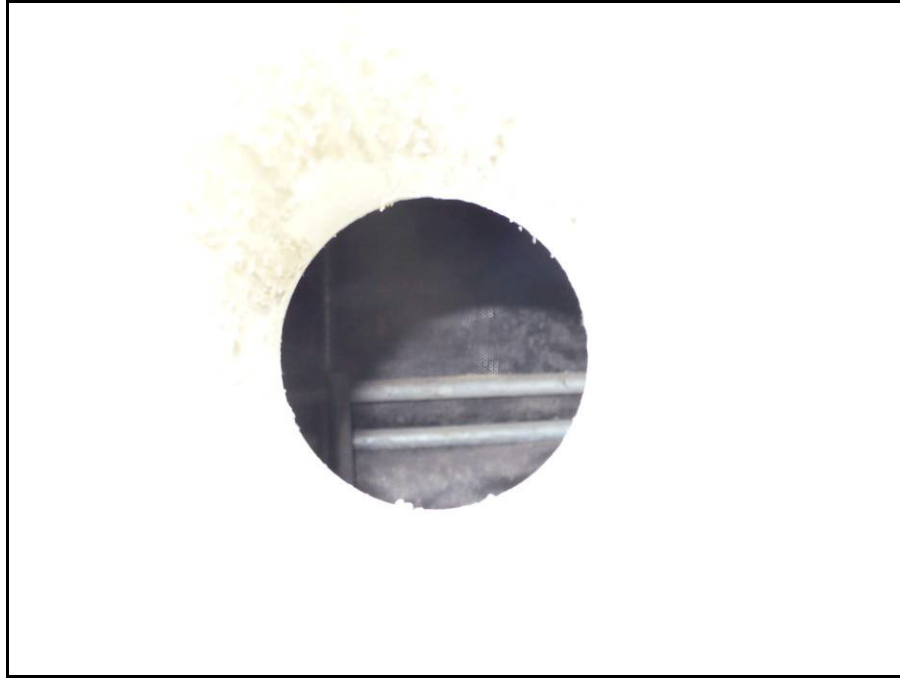
Figure 8 Typical view of welded wire mesh through coupon access hole in two-stage MSE wall

After extracting the coupons from the two-stage walls, we tried to observe the condition of the vertical welded wire mesh facing through the 2-inch access holes. We were generally able to see one or two segments of wire and/or portions of the loops/clevis ends for the connectors across the gap between the first and second stages of the wall. A typical view through an access hole for a two-stage MSE wall is shown in Figure 8. Generally, the conditions of these elements with respect to corrosion appeared to be similar to (or at least no worse than) those exhibited by the coupons themselves.

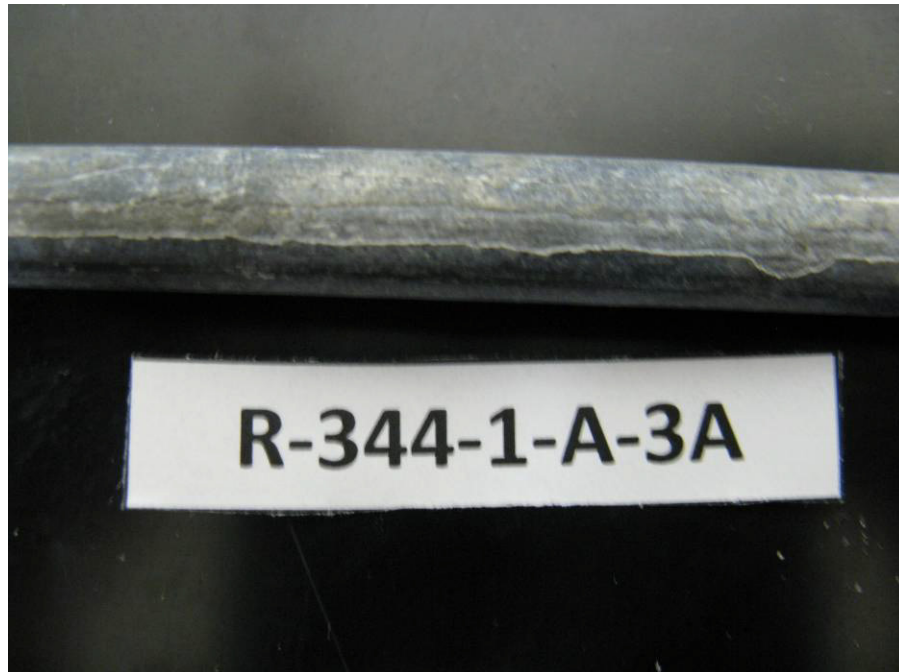
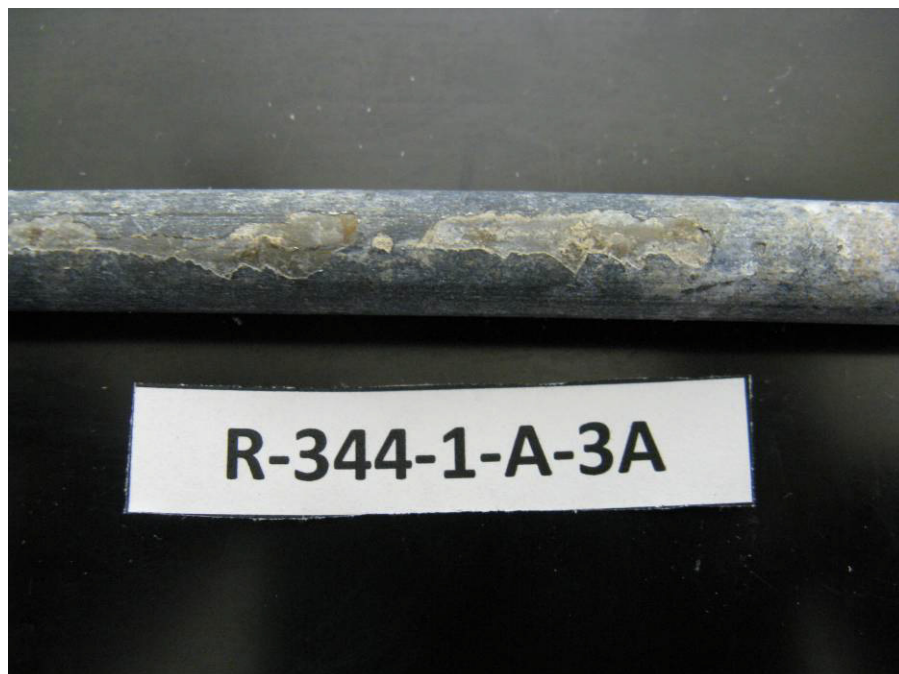
Figure 11 Photographs detailing damage/loss of galvanization for coupon R-344-1-A-3

The center portion of coupon R-344-1-A-3, specimen A, is shown in Figure 11. In the upper photograph, it appears that the zinc coating was damaged near the end of the galvanization process, leaving a long narrow strip where the galvanization detached or peeled away from the steel. Fortunately, corrosion of the underlying steel was not observed in this particular segment. However, in the lower photograph showing an area of similarly peeled zinc coating (notice the sharply defined edges for the zinc coating), steel oxidation has started. Fortunately, this corrosion is localized to only a small portion of the exposed steel, and the oxidation is shallow in

nature and absent of pitting. The presence of this kind of galvanization damage (particularly on monitoring coupons rather than production reinforcement) suggests a need for more effective inspection of MSE wall materials prior to installation.

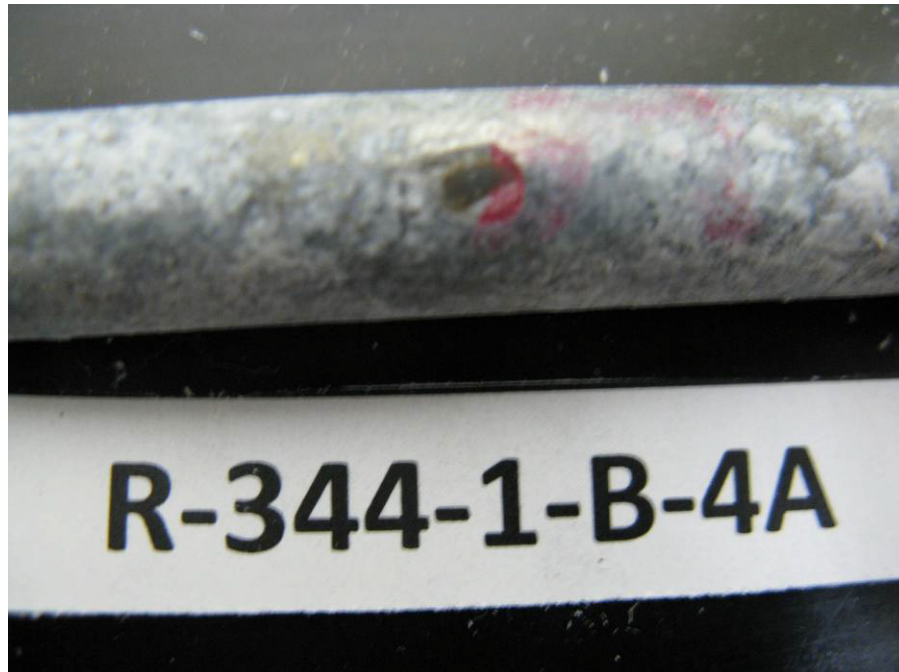
Figure 12 Photograph detailing corrosion by localized pitting on coupon R-344-1-B-4, specimen A

Figure 12 shows a section of coupon R-344-1-B-4, specimen A, located immediately behind the inner neoprene plug in the access hole. This section exhibits several small locations of steel oxidation (i.e., red rust). Figure 13 shows similar, but somewhat larger, areas of steel corrosion on coupon R-344-7-A-15, specimen A. A small area of the galvanization is missing, and the exposed steel is showing some oxidation with a textured surface beginning to become apparent.

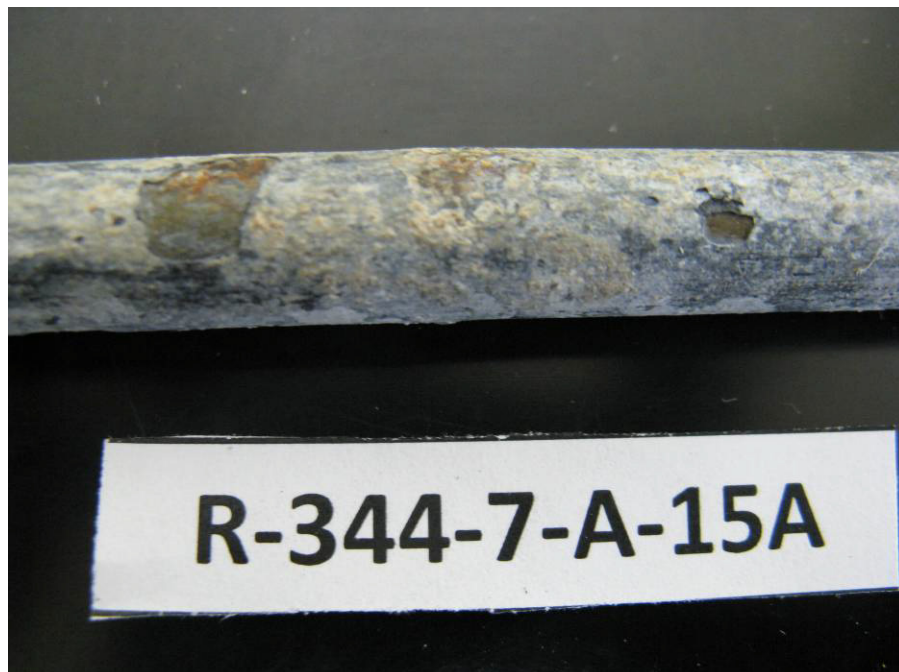
Figure 13 Photograph detailing corrosion on coupon R-344-7-A-15, specimen A

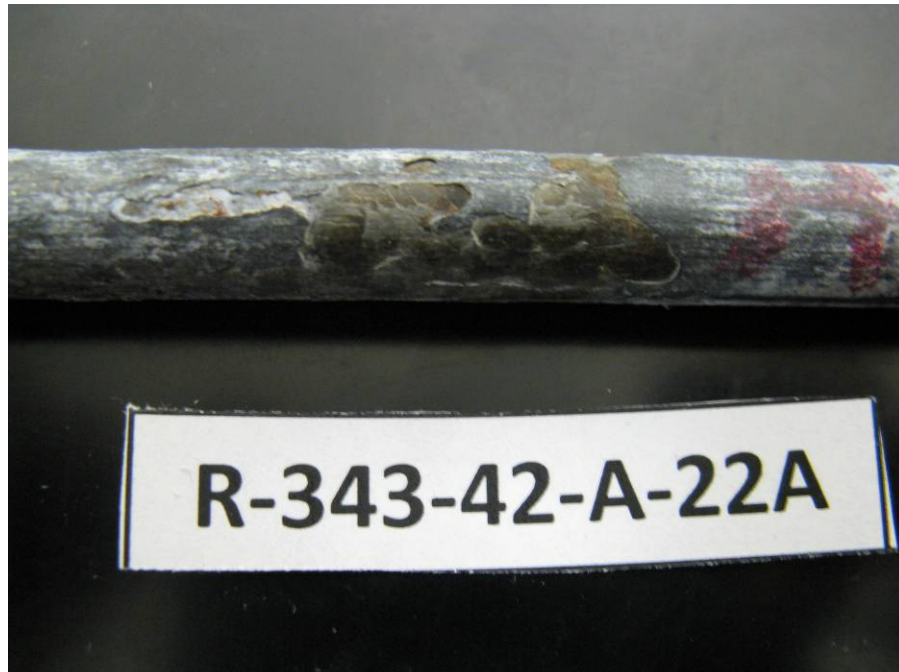
Figure 14 Photograph detailing corrosion of galvanization and steel on coupon R-343-42-A-22, specimen A

Figure 14 and Figure 15 show areas of localized steel corrosion on coupons 343-42-A-22, specimen A, and R-346-8-A-19, specimen C, respectively. The galvanization in these instances (particularly the former) appears to have smoother edges, leading us to suspect that these instances represent anionic depletion of the zinc rather than mechanical damage prior to the

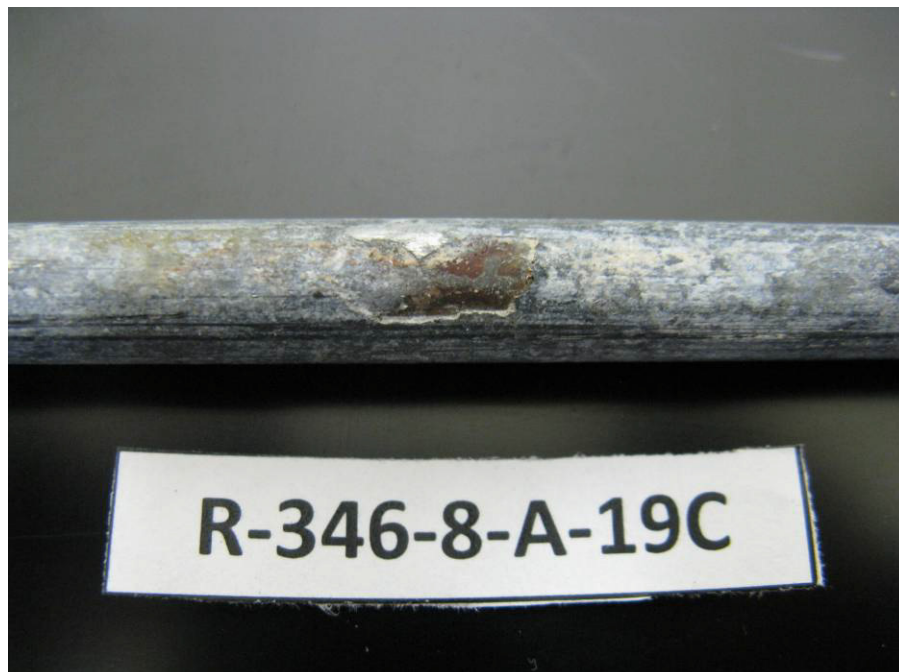
Figure 15 Photograph detailing localized corrosion on coupon R-346-8-A-19, specimen C

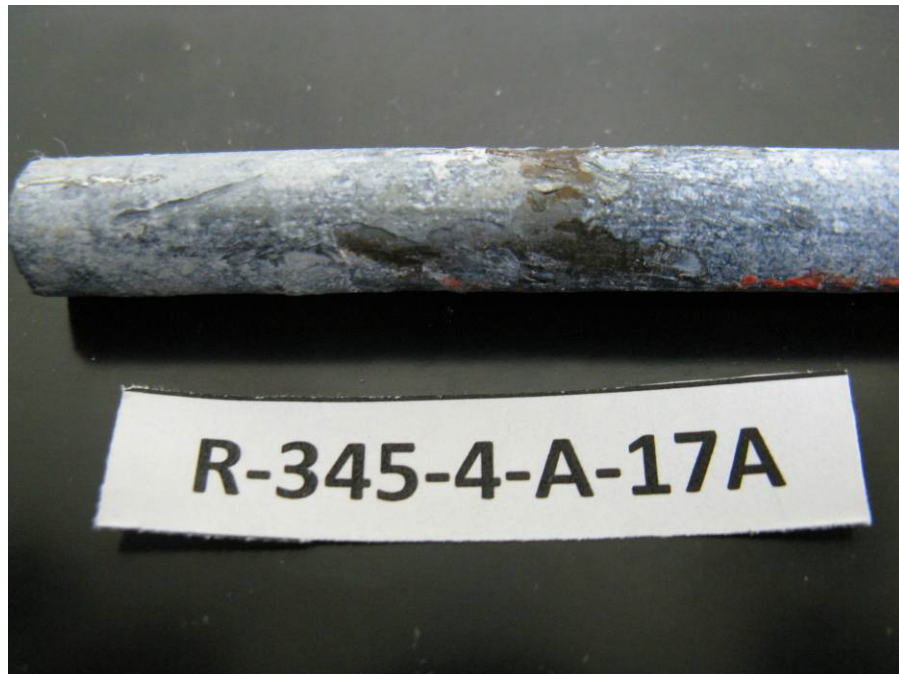
Figure 16 Photograph detailing localized corrosion on coupon R-345-4-A-17, specimen A

corrosion of the steel. The latter instance is the greatest loss of steel that we measured. Figure 16 shows coupon R-345-4-A-17, specimen A, with an instance where steel oxidation is present on a segment of the coupon, and extends a significant portion along the coupon circumference. The measurement of diametral steel loss was taken at the darkest and apparently most severe location at the top of the specimen as shown in the photograph.

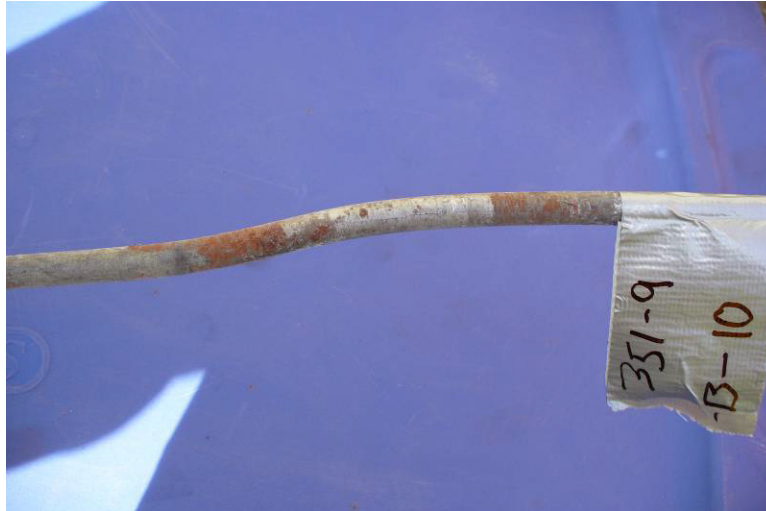
Coupon R-351-9-B-10 is of particular note with respect to the corrosion we observed. This coupon was initially extracted to help assess vertical variations in corrosion by comparing it with coupon R-351-9-A-9 which was located at the same horizontal location in a wall, but at a lower elevation. However, as the coupon was extracted, it was obvious that the coupon had been damaged either at, or prior to, installation. The bent coupon is shown in Figure 17. The galvanization appears to have flaked or spalled in the areas of greatest bending, and steel has subsequently corroded. This portion of the wire coupon was located near the wall face, just inside the panel access hole and in the open-air gap between the first and second stages of the MSE wall. Photographs showing greater detail of the damaged portions of the wire coupon are provided in Figure 18. The penetration of the rust is relatively shallow with some surface texture becoming apparent. The thickness of the flaking galvanization shown in the pictures is about 3 mil and the corrosion of the steel corresponds to a diametral loss of about 1 mil. The damage and corrosion observed on this coupon highlights the importance of avoiding excessive bending of MSE wall reinforcement elements during pre-installation handling and construction.

Figure 17 Damage and subsequent corrosion of coupon R-351-9-B-10 near panel face of two-stage MSE wall

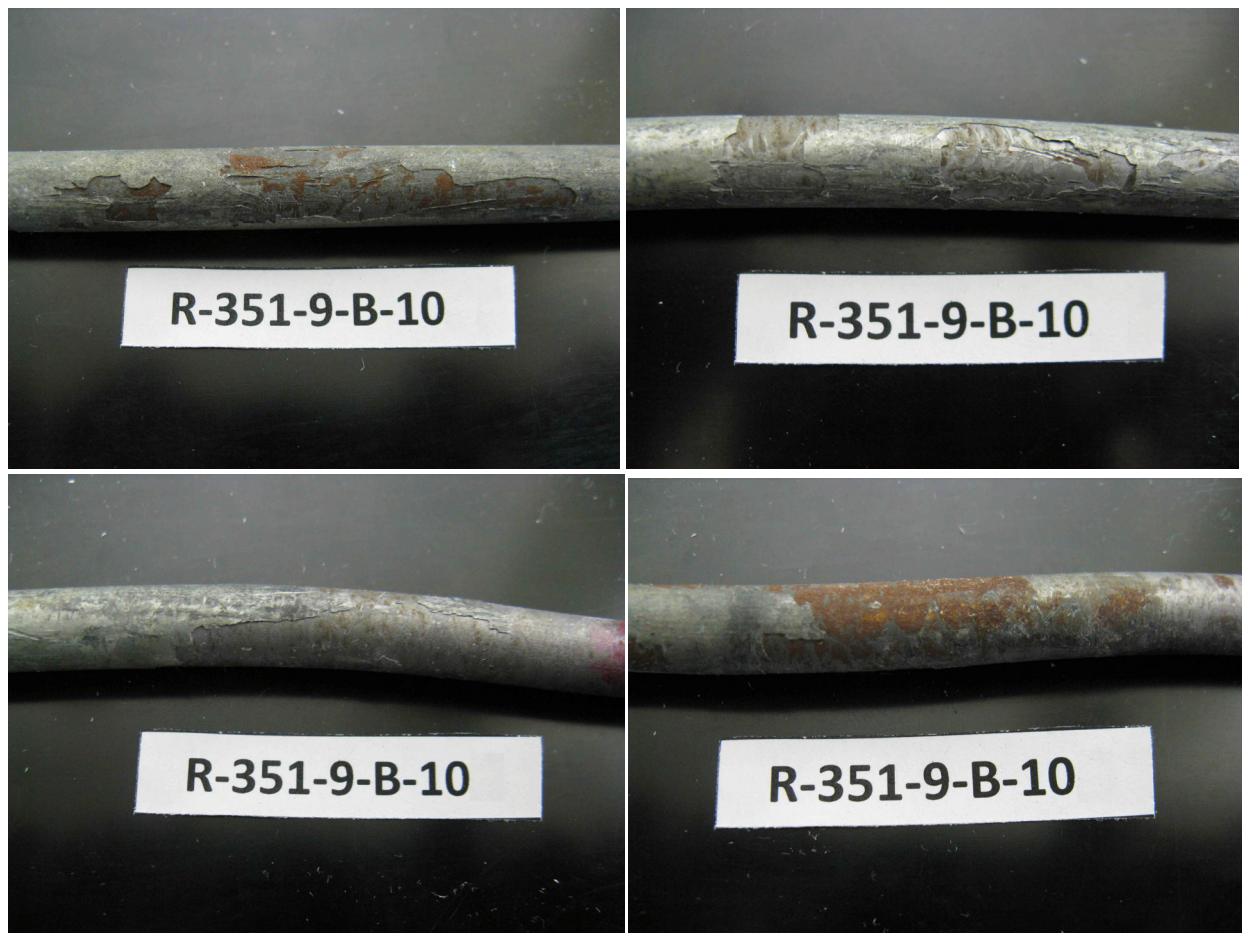
Figure 18 Photographs detailing damage and subsequent corrosion near end of coupon R-351-9-B-10
